Asbestos Management Survey Report

6-9 Lumley Close, Swindon, SN5 6JD

Management Survey to the communal areas only

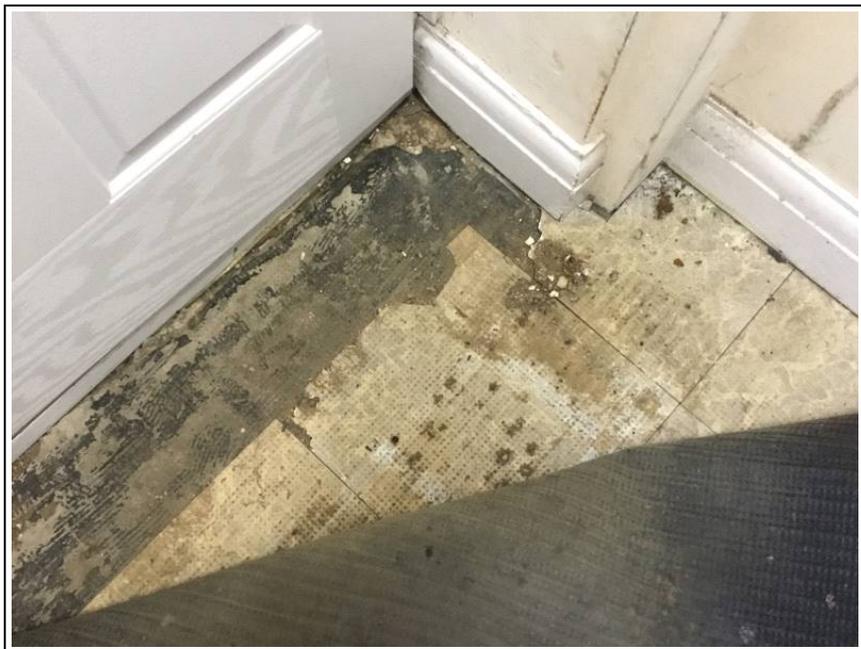
Survey Data Sheet: Conclusions & Recommendations
 Site Location: 6-9 Lumley Close, Swindon, SN5 6JD
 Building Designation: Building 01
 Unique item Number: 1

Sample Ref	Fl	Location	Description	Qty	Analysis Result	Total M.A.S	Licensed Material Y/N
CT000131	Ground Floor	G.01 - Entrance Hall	Floor (under carpet) - Vinyl tiles & bitumen adhesive - Well Bound Material	2m ²	Chrysotile	3	N

Product Type	Extent of Damage	Surface Treatment	Asbestos Type	Total M.A.S	Accessibility/Vulnerability	Combined Total for Advised Timescale
1	1	0	1	3	0	3

Recommended Action:
 Repair/Encapsulate

This material requires repair or encapsulation within current legislative requirements. Thereafter it may remain in situ and be managed accordingly. No drilling, cutting or any abrasive actions should take place on this material.

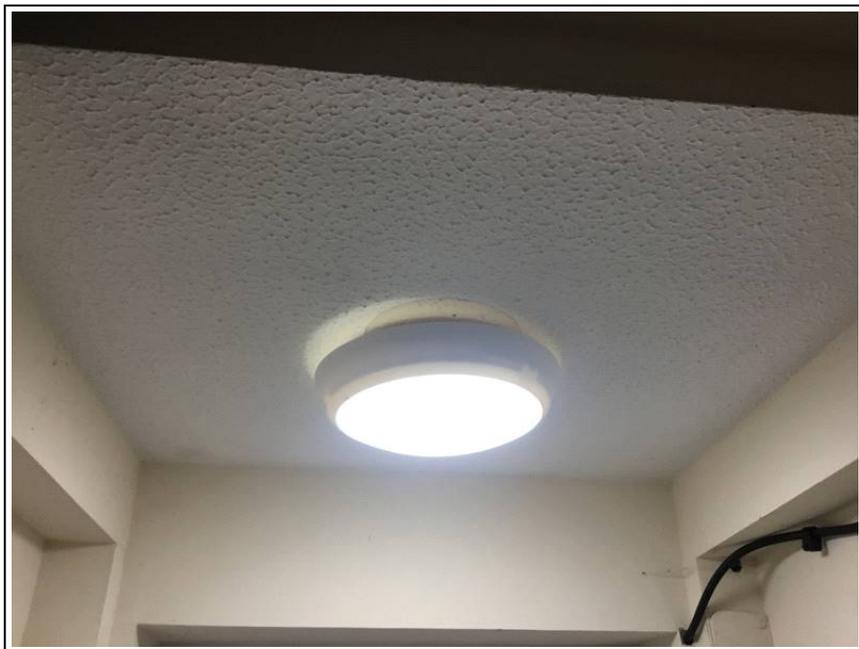
Survey Data Sheet: Conclusions & Recommendations
 Site Location: 6-9 Lumley Close, Swindon, SN5 6JD
 Building Designation: Building 01
 Unique item Number: 2

Sample Ref	Fl	Location	Description	Qty	Analysis Result	Total M.A.S	Licensed Material Y/N
CT000132	Ground Floor	G.01 - Entrance Hall	Ceiling - Textured coating - Textured Coating	1m ²	NADIS		N/A

Recommendations:
 No asbestos detected in sample

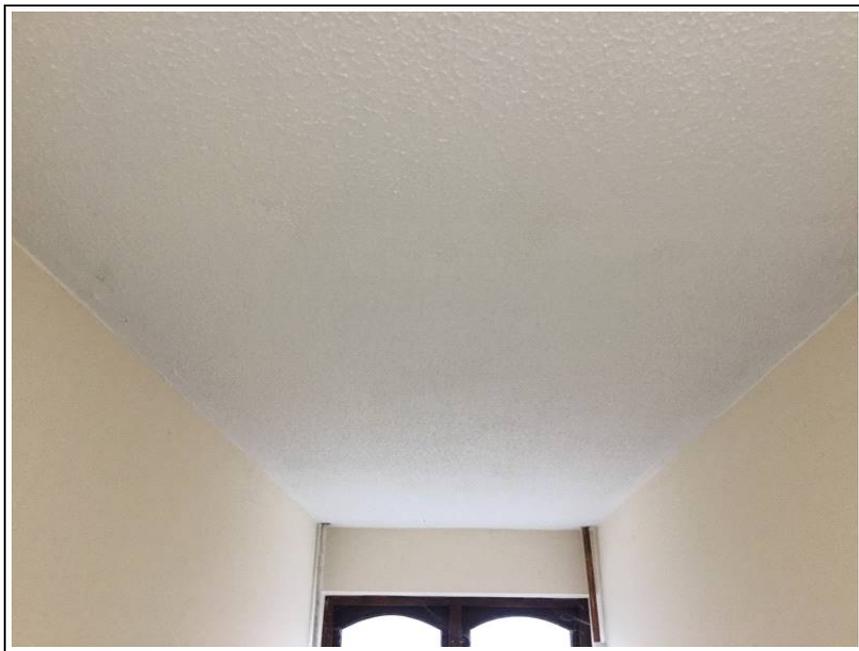
Survey Data Sheet: Conclusions & Recommendations
 Site Location: 6-9 Lumley Close, Swindon, SN5 6JD
 Building Designation: Building 01
 Unique item Number: 3

Sample Ref	Fl	Location	Description	Qty	Analysis Result	Total M.A.S	Licensed Material Y/N
CT000133	1st Floor	1.01 - Landing	Ceiling - Textured coating - Textured Coating	5m ²	NADIS		N/A

Recommendations:
 No asbestos detected in sample

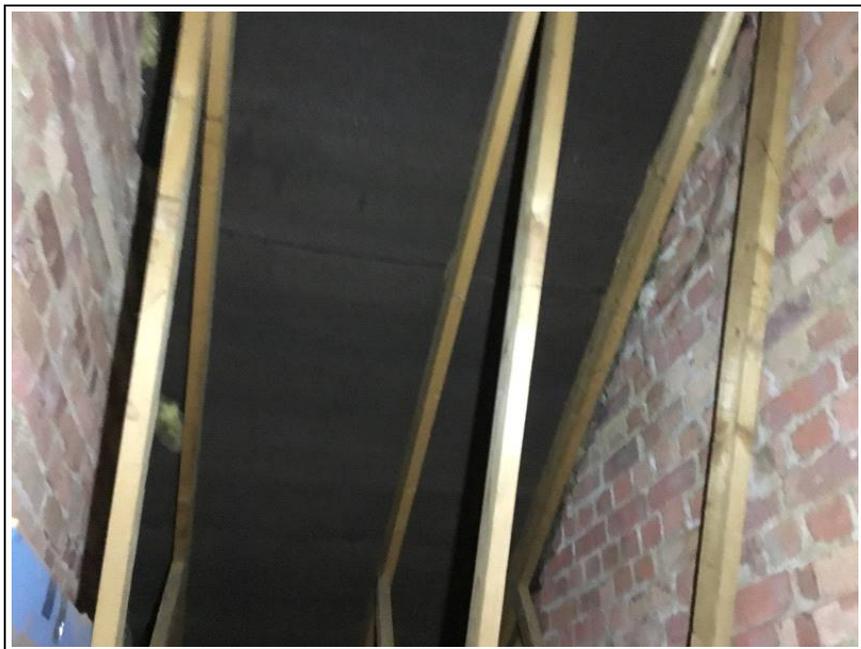
Survey Data Sheet: Conclusions & Recommendations
 Site Location: 6-9 Lumley Close, Swindon, SN5 6JD
 Building Designation: Building 01
 Unique item Number: 4

Sample Ref	FI	Location	Description	Qty	Analysis Result	Total M.A.S	Licensed Material Y/N
CT000134	Roof Void	Attic	Inner roof - Underfelt - Well Bound Material	10m ²	NADIS		N/A

Recommendations:
 No asbestos detected in sample

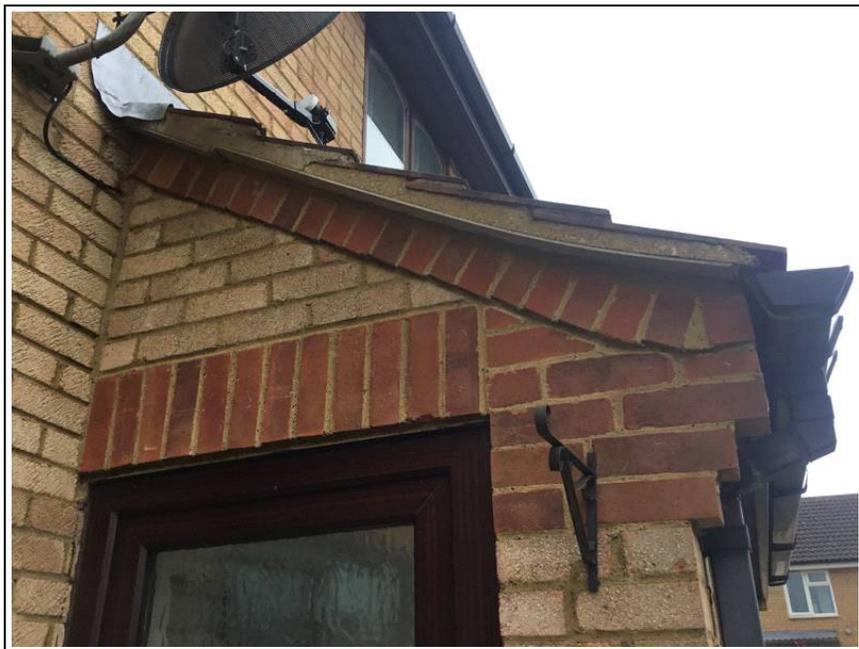
Survey Data Sheet: Conclusions & Recommendations
 Site Location: 6-9 Lumley Close, Swindon, SN5 6JD
 Building Designation: Building 01
 Unique item Number: 5

Sample Ref	FI	Location	Description	Qty	Analysis Result	Total M.A.S	Licensed Material Y/N
CT000135	External	External	Roof (lower level) - Underclanking - Asbestos Cement	3lm	Chrysotile	3	N

Product Type	Extent of Damage	Surface Treatment	Asbestos Type	Total M.A.S	Accessibility/Vulnerability	Combined Total for Advised Timescale
1	0	1	1	3	0	3

Recommended Action:
 Leave & Manage

This material may remain in situ and be managed accordingly. Undertake continued regular recorded inspections on the condition of the material as dictated in the asbestos register and management plan. No drilling, cutting or any abrasive actions should take place on this material.

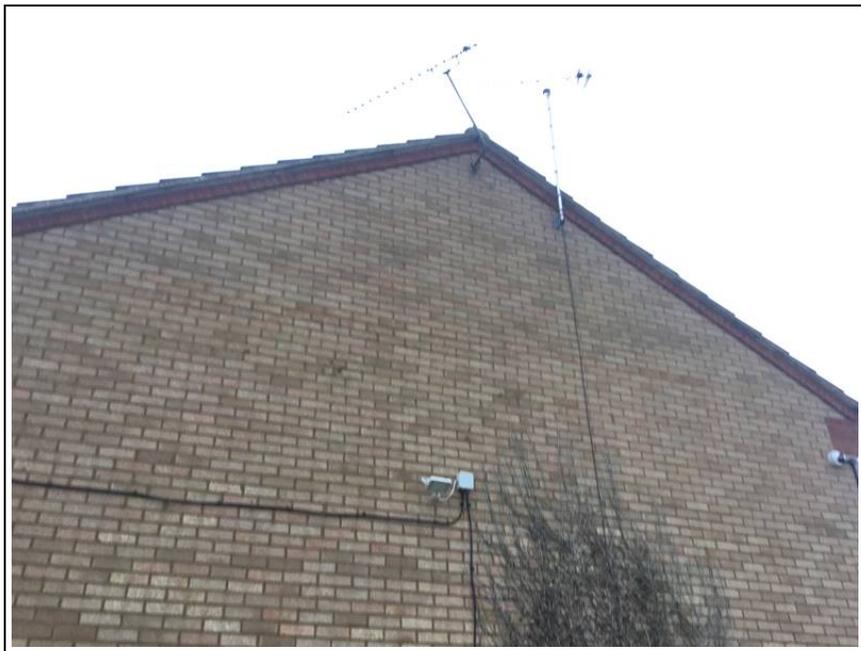
Survey Data Sheet: Conclusions & Recommendations
 Site Location: 6-9 Lumley Close, Swindon, SN5 6JD
 Building Designation: Building 01
 Unique item Number: 6

Sample Ref	FI	Location	Description	Qty	Analysis Result	Total M.A.S	Licensed Material Y/N
REFER (CT000135)	External	External	Roof (upper level) - Undercloak - Asbestos Cement	18lm	Chrysotile	3	N

Product Type	Extent of Damage	Surface Treatment	Asbestos Type	Total M.A.S	Accessibility/Vulnerability	Combined Total for Advised Timescale
1	0	1	1	3	0	3

Recommended Action:
 Leave & Manage
